# Manhole Inspection Summary

Manhole # S43G\_\_028MH

Insp Date: **6/2/08 10:40 AM**

**Location** Address: **e pratt st**

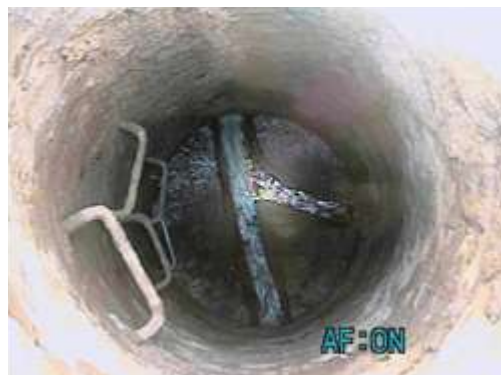
Top View

top view & steps

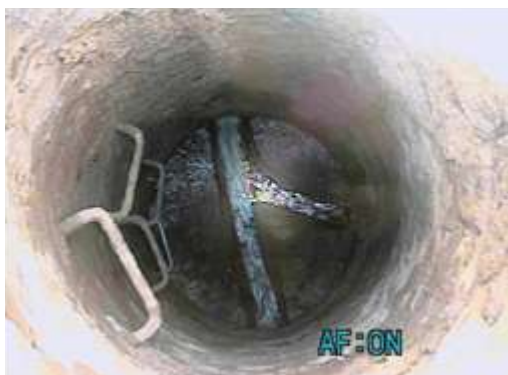
defect 4

Count: **6** Missing: **0** ☒ **Corroded**

corroded steps

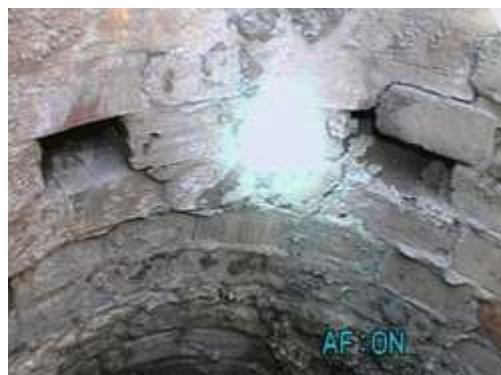
Defect 3

Condition: ☐ Sound ☒ **Cracked** ☐ Root Intrusion ☒ **Loose Brick** ☐ Deteriorated

corbel cracked & missing/loose bricks

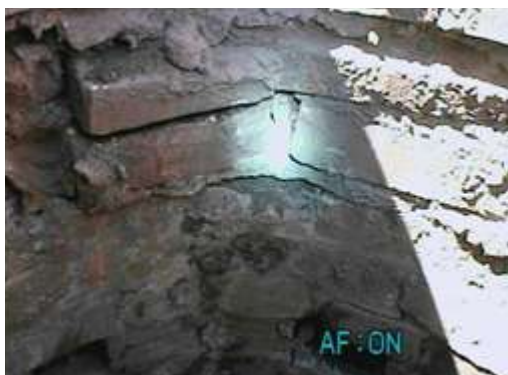
Defect 2

Condition: ☐ Sound ☒ **Cracked** ☐ Root Intrusion ☒ **Loose Brick** ☐ Deteriorated

cracked, loose bricks, frame adj

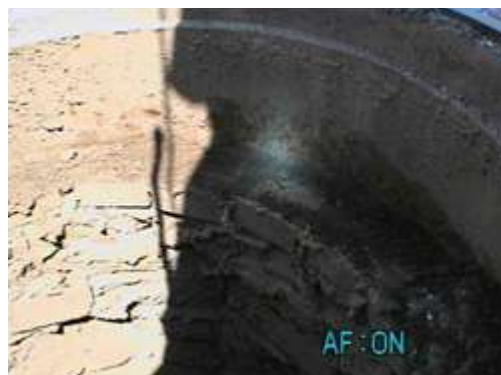
Defect 1

Offset: **6** (in.)

offset

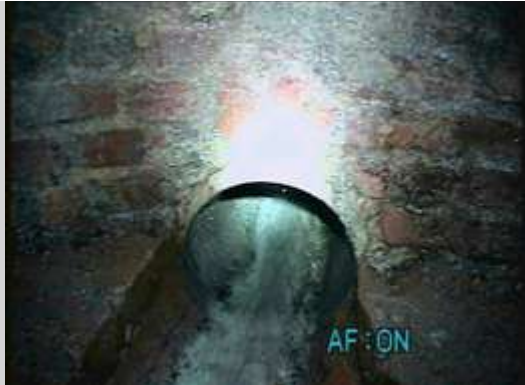
12 O'Clock Outflow

8 in. Circular Gravity Sewer  
Pipe Out @ 12 O'Clock

Invert Depth: 13.13 (ft.) Flow Characteristics: **Fast**

Infiltration: **None** Pipe Seal Cond: **Unknown**

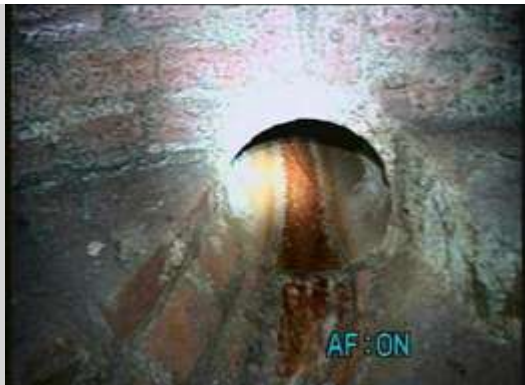
3 O'Clock Inflow

8 in. Circular Gravity Sewer  
Pipe In @ 3 O'Clock

Invert Depth: 12.97 (ft.) Flow Characteristics: **Fast**

Infiltration: **None** Pipe Seal Cond: **Unknown**

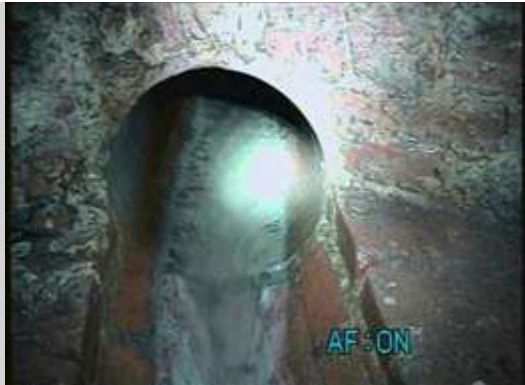
6 O'Clock Inflow

8 in. Circular Gravity Sewer  
Pipe In @ 6 O'Clock

Invert Depth: **12.96** (ft.) Flow Characteristics: **Fast**

Infiltration: **None** Pipe Seal Cond: **Unknown**
